Lessons from Losses

Incident: As the winter logging season was reaching its last month of work before spring break-up, a track feller buncher abruptly tipped over when the operator tried to fell a large white pine. Due to the position of this equipment the machine completely rolled on one side and partially on its top. The tracks were in the air and the side panels were blocked.

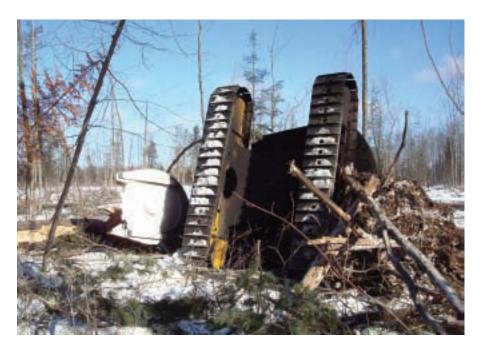
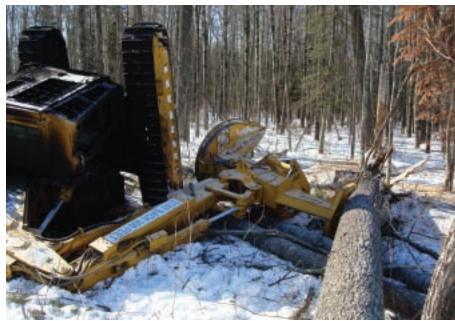
their fire trucks there was nothing they could do to save this equipment. Fire fighters did respond with two hand-held extinguishers, but the fire was too large for this protection. By this time, the fire had already spread to the cab and the machine was a complete loss. All that could be done is contain the fire to the equipment involved, be sure the fire did not spread to the surrounding area, and prevent possible personal injury. There is some salvage value with the felling head.

It is believed that the probable cause of this loss is operator error and training in the limits of this equipment during operation. The sudden tip-over that created this situation led to this fire situation. The actual ignition cause is uncertain (oil, fuel, debris, etc.). Some other problems that added to this situation were the on-board self-suppression system failed in the automatic mode, the manual activation could not be reached after the fire started, and the side panels/doors could not be opened to address the base of the fire with fire extinguishers.

1. Complete initial and refresher employee training for proper operation, service, emergency response, etc. for new and existing employees. These training needs change with each job site.

- 2. Review all equipment for the placement of fire port holes to assist in extinguishing a fire in an emergency situation. The placement of these fire port holes need to be in high fire hazard areas on all equipment (manifold turbo/area, starter/alternator area, battery area, etc.). Fast access is very important in an emergency.
- 3. Frequent operator self-inspections for housekeeping and maintenance, especially in dirty timber.
- 4. Always shut down the electrical disconnect (master switch) on your mobile equipment in an emergency situation. Refresher

- training for all employees must be reviewed regularly.
- 5. Train employees on proper use of fire extinguishers in an emergency situation. Utilizing the extinguisher hose to direct the flow to the base of the fire and not wasting the extinguisher in a panic situation.
- 6. Install an on-board fixed self-suppression system on all mobile equipment. Additional protection is always very beneficial in a fire emergency situation. Always follow the owner's manual maintenance required for regular maintenance. Also self inspection is crucial to the performance of this protection.
