Fire Strikes Feller Buncher During Shutdown

by Dave Amundson
Lumbermen's Underwriting Alliance

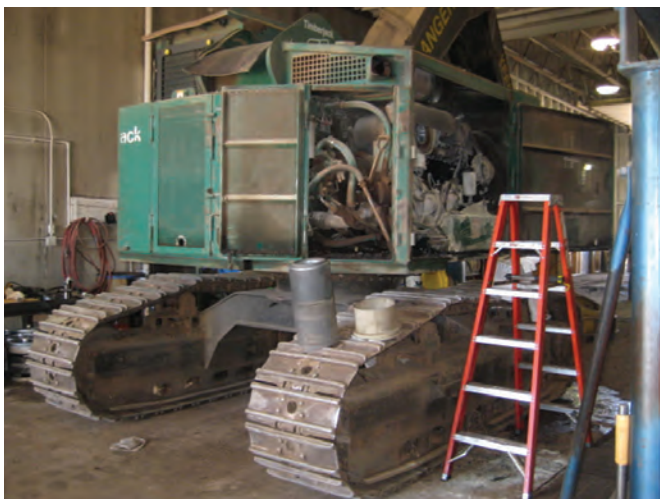
Due to this fire, damage occurred to the starter, batteries (leaking battery acid), and electrical cables within the engine compartment. This area of involvement was under the manifold/turbo of the engine, next to the starter, and above the battery storage area. Proper preparation and fast response limited the amount of loss and saved this mobile equipment from a total loss.

Fire damage occurred within the lower engine compartment on this feller buncher.

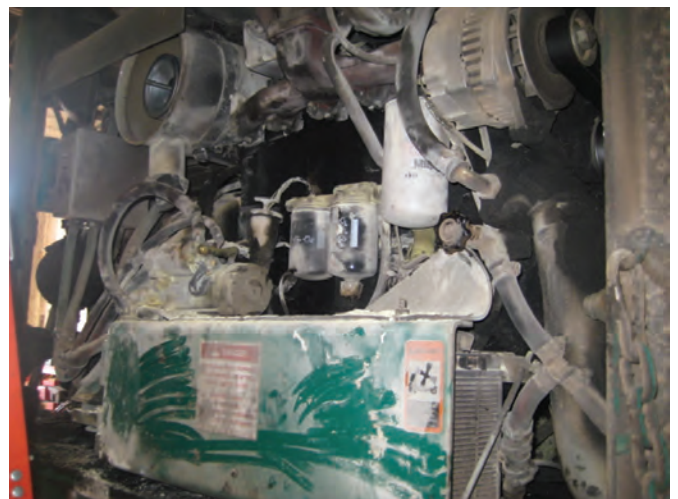
It is uncertain exactly what failed, thus igniting the fire. It is speculated that either the batteries shorted

The main fire was located behind the battery cover, involving the batteries and surrounding engine area.

internally and/or there was a direct short to the main battery cables leading to the starter. Housekeeping likely contributed to the fire, due to the area of this fire situation.

1. Complete thorough self-inspections on a regular basis to maintain good housekeeping, correct maintenance problems quickly, and be sure adequate fire protection is available. Review your job site for proper equipment/supplies as well as property and personal protective items.

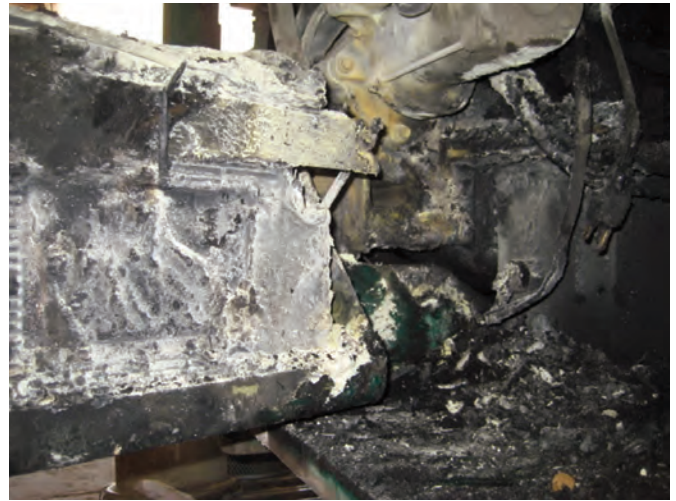
The batteries, electrical wiring, and starter area were damaged on this feller buncher.

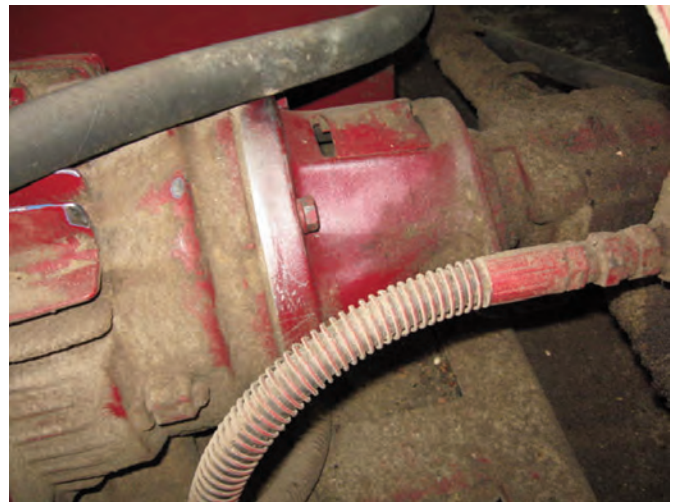
Please note the accompanying pictures highlighting the damaged area on the involved feller buncher. For sawmill operators, there is a picture of a recent situation of a similar nature at a sawmill involving a hydraulic unit. The possible housekeeping / maintenance breakdown involving the coupler joint between the hydraulic pump and electric motor was the hot area. Again, handheld fire protection (minimum 10lb multi-purpose fire extinguishers) were used and successfully extinguished the fire. Having an emergency action plan in place for all operations of the wood industry will make the difference in protecting your property and preventing personal injury.

This photo shows the near miss at a sawmill involving a hydraulic unit where the coupler housing was the area of concern between the electric motor and the hydraulic pump. The fire was contained inside the coupler housing.
