Vehicle Accident on Winter Mixed-Use Road

Lessons from Losses

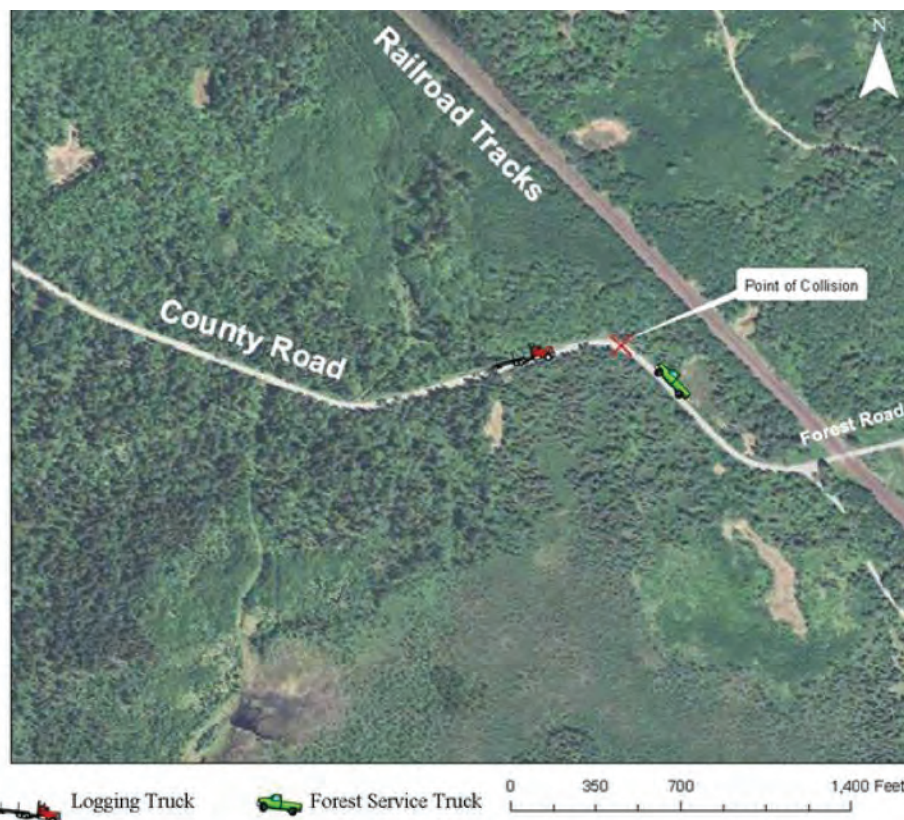
The impact of the log truck pushed the Forest Service vehicle into the snow bank on the passenger side. The collision was sufficient to cause the Forest Service vehicle's airbags to deploy. The two snowmobiles broke free of their secured mounts on the trailer

and one landed in the roadside ditch approximately 40 feet beyond the trailer.

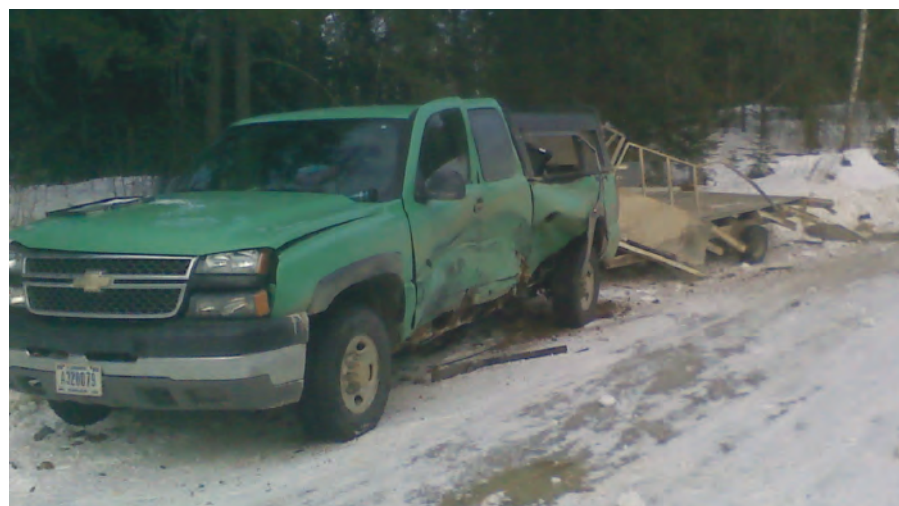
Damage to the Forest Service pickup and snowmobiles exceeded their value. The log truck also sustained major damage: its rear axle was bent back at a 30 degree angle, rendering the vehicle inoperable. Additional damage occurred to the log truck's wheel in front of the rear axle. The log truck

driver was not injured.
