# Vandalism Strikes Two Pieces of Logging Equipment

by Dave Amundson  
Lumbermen's Underwriting Alliance

## Lessons from Losses

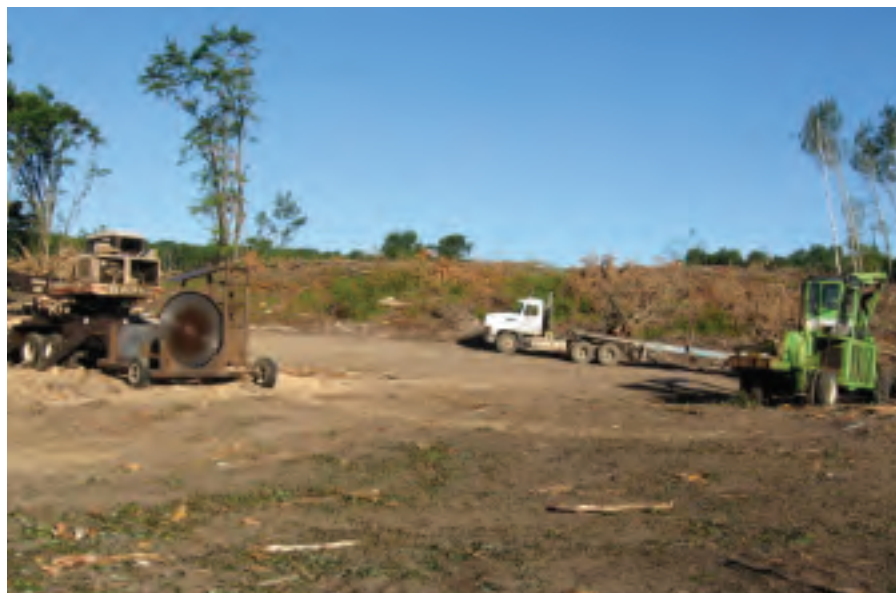
Separation of mobile equipment at log landing.

3. Lock fuel, oil and engine compartments to prevent tampering. Add locks if they did not come installed from the factory.
4. Park equipment away from ignition sources. Stay back from slash piles that could be ignited. Space equipment at least 50 feet apart to reduce chance of fire spreading from one machine to another.

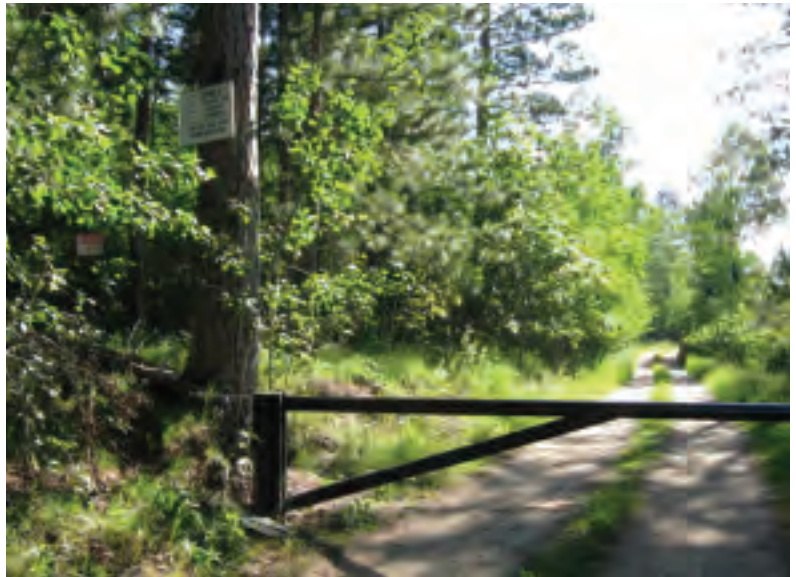
**Permanent gate and signage used to block access.**

1. Restricting vehicle access to job sites during off-hours is one of the best ways to protect equipment. Use a gate, boulders, dirt berm, or a drag of trees to stop traffic.

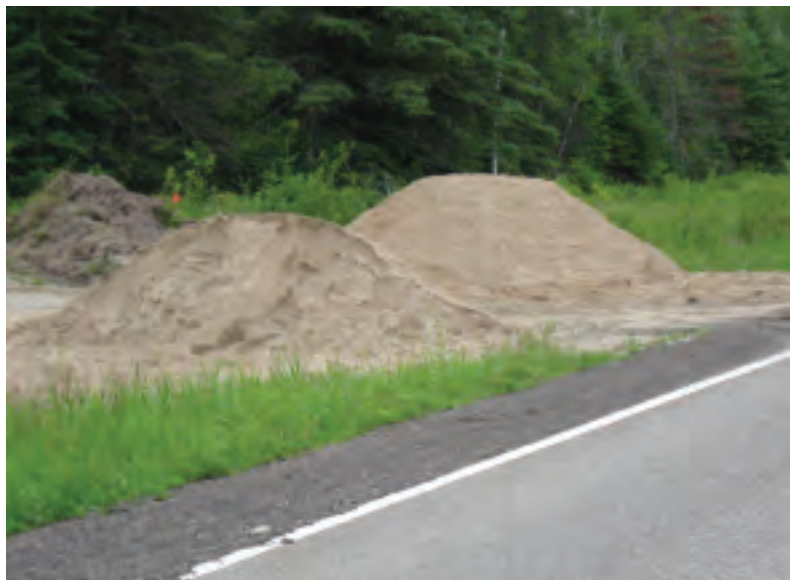
**Dirt berm used to block road access.**

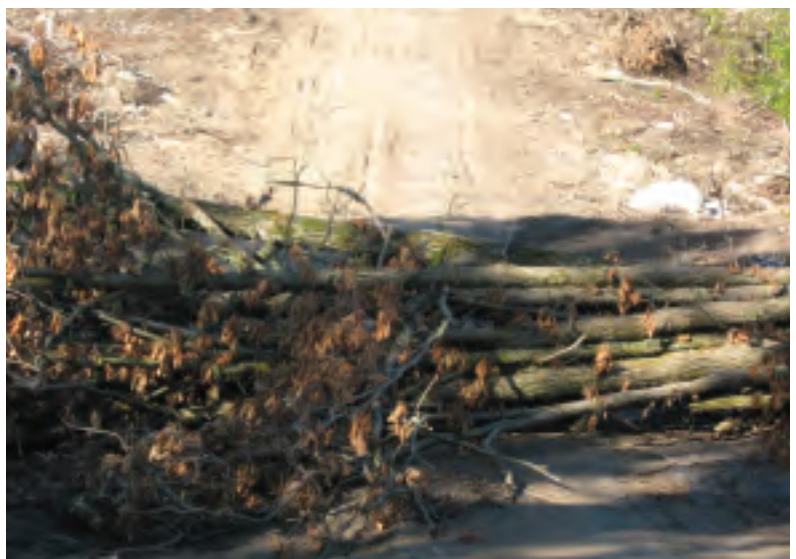
**Drag of wood used to block access on a short-term basis.**
