Logging Death Occurs During Shut Down of Grinder Unit

by Dave Amundson
Lumbermen's Underwriting Alliance

Lessons from Losses

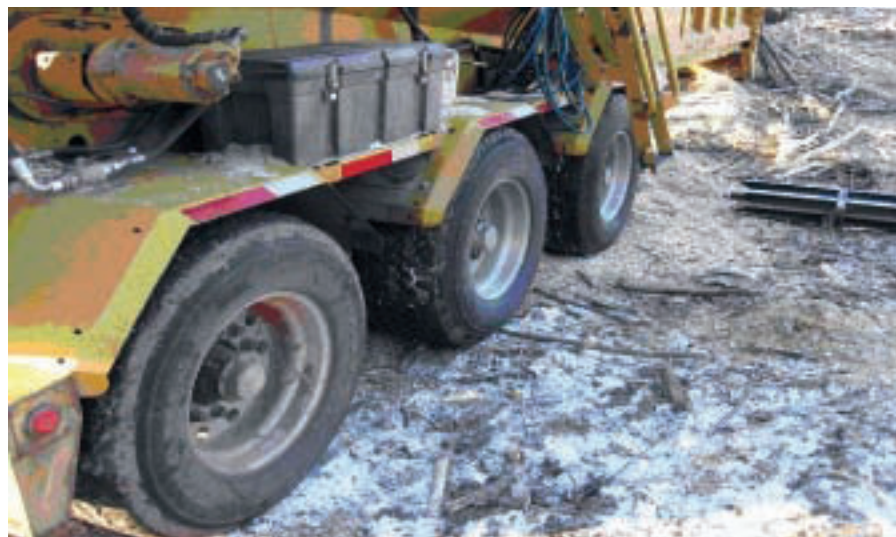
The grinder involved in this accident, including a look at the spacing between the axles.

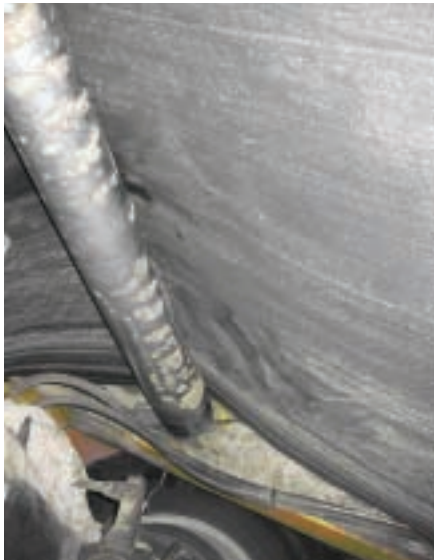
The grinder's belt/roller system looking up from the ground.

system violently pulled him and his arm into the roller up to his shoulder, striking his head against the roller causing severe head trauma and death.

It is uncertain why this individual made the decision to take the risk in crawling under this unit and reaching into a moving pinch point. With that being said, the most likely probable cause of this tragic logging accident is the failure to follow proper lockout/tagout safety procedures.

1. Always follow safe lockout/tagout procedures on all mobile equipment and machines before any maintenance, service and/or repair is completed. Do not take short-cuts and excess risk when working on the job and/or even away from your employment. Remember, sometimes you have to slow down to go faster!
2. Complete safety lockout/tagout refresher training on a regular basis. Tool box refresher training and enforcement in proper work procedures can not be overlooked.
3. Be alert to loose clothing and enforce all employees to restrict the use of this type of clothing while working around moving hazards. Belts/pulleys,

chain/sprockets, rotating shafts, slow moving pinch points, etc. are just some of the high hazard examples. Every work location may and can present a different safety concern or situation.
