Lessons from Losses

Broken Access Steps Lead to Close Call

by Dave Amundson
Lumbermen's Underwriting Alliance

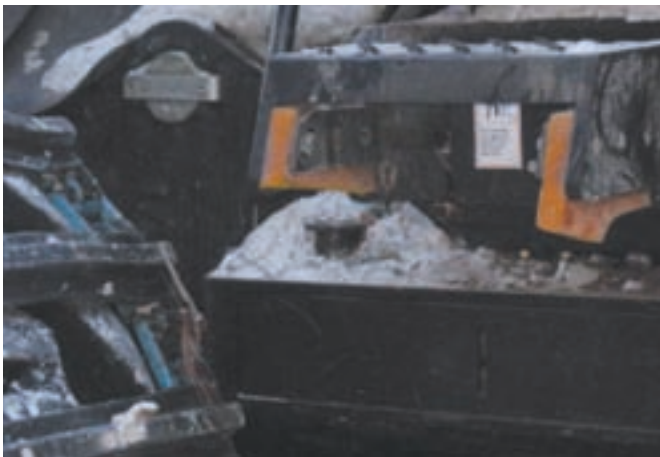
An example of broken steps on mobile equipment.

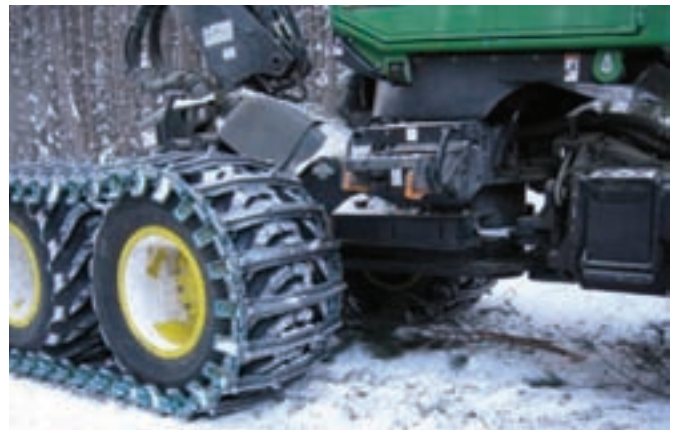
This is an example of broken steps on mobile equipment where the ground-to-step height is stressed.

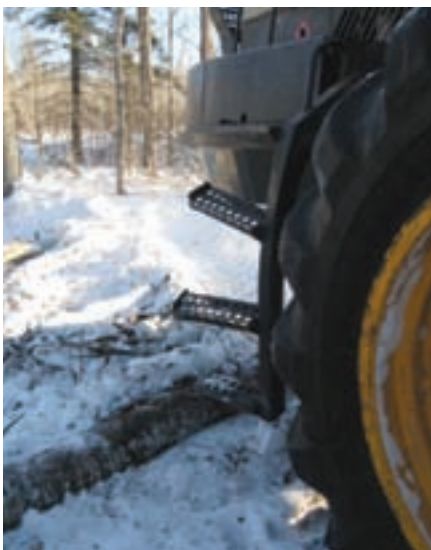
Steps in poor condition on mobile equipment may lead to problems.

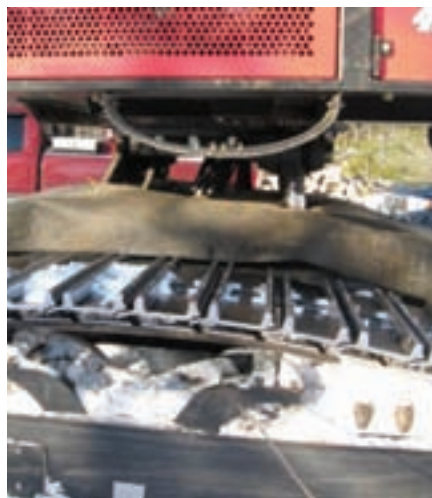
Another example of extra steps being added to mobile equipment to improve access and maintenance (both sides of machine).

4. Review all mobile equipment for safe access steps. In many situations it may be necessary to add more steps, hand holds, etc. even on newer mobile equipment.
5. Also, review these safety measures on your truck and trailer units as drivers secure their loads, access loaders, etc.

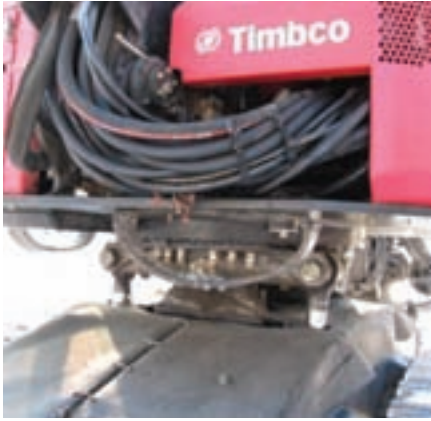
This is an example of additional steps added to mobile equipment for maintenance purposes.
