Feller Buncher Burns in Late Winter While Being Operated

Lumbermen's Underwriting Alliance

Lessons from Losses

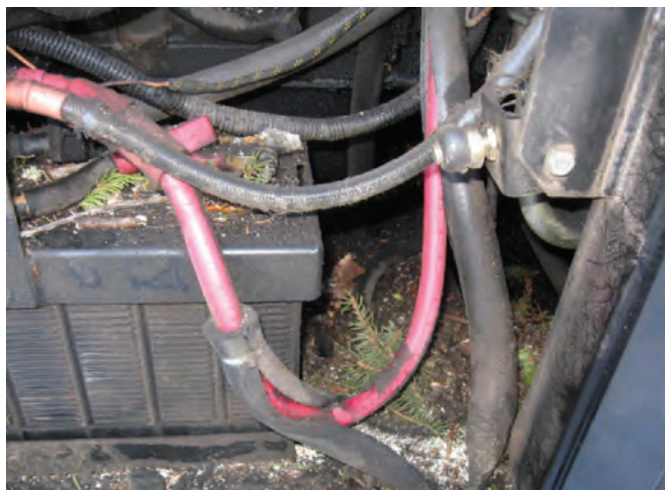
This picture shows where daily housekeeping would improve fire and personnel safety as well as being able to uncover maintenance needs.

- Understanding the use of the fire protection access port holes, which access doors to open and/or not to open, and the maintenance of quick-opening fasteners on the engine/hydraulic access doors.
 - Training in the proper use of portable multi-purpose fire extinguishers. Always maintain a minimum of either one 10 lb. or two 5 lb. extinguishers in all mobile equipment when operating. In high hazard mobile equipment, two 10 lb. extinguishers are recommended.
 - Setting-up an emergency call number list with directions to the logging site location. Practice good communication.
2. Complete a high standard of housekeeping on all mobile equipment. This includes daily cleaning during equipment checks, power washing during

maintenance times (especially when fuel, hydraulic/engine oil, etc. is leaked), and as needed throughout the year.

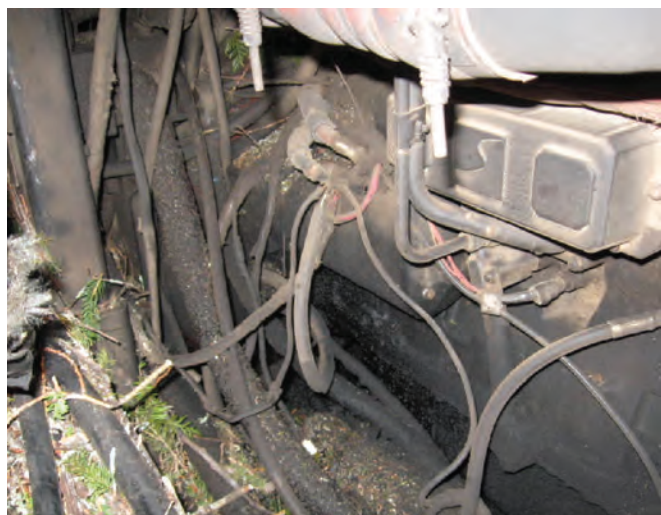
This picture demonstrates the need for improved daily housekeeping and a routine power wash.

leaked into the rear of the engine/hydraulic area. This was noted during the repair of the fuel problem, but no follow-up was taken. This may have been a contributing factor in the growth of the fire.
