Readily Available Fire Extinguishers Put Fire Out on Logging Mobile Equipment

by Dave Amundson
Lumbermen's Underwriting Alliance

Lessons from Losses

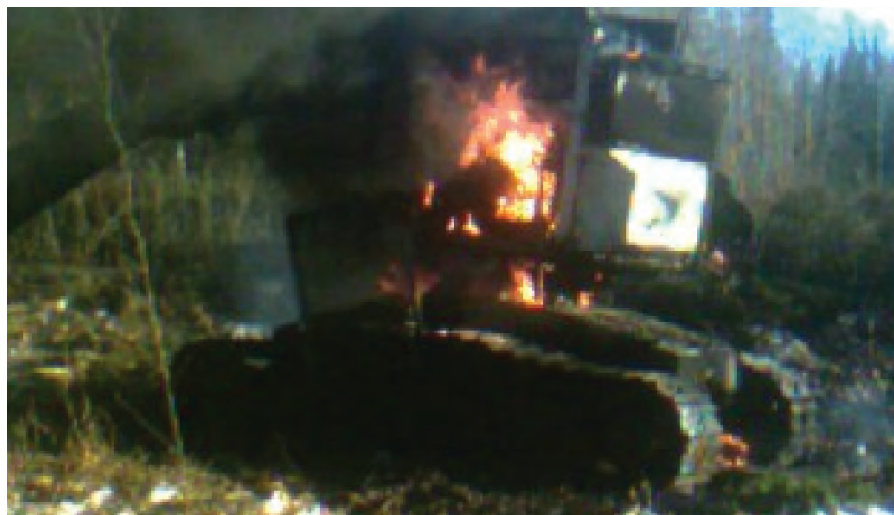
During operation of the feller buncher on a midweek morning, a fire broke out in the engine compartment. Leading up to this fire situation, the operator noticed that the engine started to labor. This caused him to check the gauges and the engine

compartment. Smoke was seen coming from the left side of the engine compartment. Following his emergency response plan, he shut down the machine and used the on-board 10-pound hand-held multi-purpose fire extinguisher to fight this fire. The fire was initially attacked through the rear left side panel where the flames were more intense, and again after opening the left side panel. The fire was extinguished, but not before damage to some of the engine components. In this situation, this individual felt that over 2/3 of the 10 lb. fire extinguisher was used. Fast action can and will payoff with a good emergency plan. No personal injury occurred.

It is believed that the electric fuel pump failed, and this may have led to an electrical fire that grew large enough to rupture the air conditioning lines, some water lines, multiple fuel/hydraulic lines and damage some other electrical wiring/engine components.

This is what can go wrong very quickly! No one can afford these types of problems.

2. Follow proper shutdown procedures of all mobile equipment when parking for the day, completing maintenance, and/or in emergencies. This includes shutting down the electrical disconnect (master switch).

3. Install and maintain either one 10 lb. or two 5 lb. fully-charged multi-purpose fire extinguishers on all mobile equipment when operating. In high hazard mobile equipment, two 10 lb. extinguishers is recommended.

4. Maintain quick-opening fasteners on the engine/hydraulic panels on all mobile equipment. Fast access to interior areas is very important in an emergency.

5. Maintain good housekeeping practices in the engine/hydraulic compartments on all mobile equipment. Daily inspection and cleaning is the norm. Good housekeeping leads to good maintenance.

6. Review and inspect special maintenance concerns involving electrical wiring/harnesses, electrical components, possible damage to hydraulic lines and fuel lines, as well as other trouble spots. Thorough self-inspections will help keep your equipment operating safely.
