Lessons from Losses

Forwarder Bursts into Flame Idling at the Log Landing

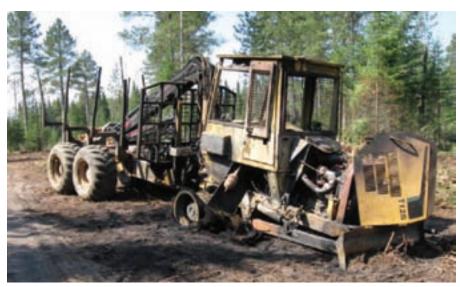
The forwarder from this incident after it was gutted by fire.

held fire extinguisher (a 10-lb. extinguisher) the flames were high on the engine near the top. As he started to extinguish the fire, the on-board starter assist canister burst and flew past, narrowly missing him. The first extinguisher slowed the fire but did not extinguish the fire. He immediately got help from his son, called 911, and gathered the extra fire extinguisher from the company pick-up to attempt to control the fire. The fire was out of control and all they could do was use the extra forwarder to blade the surrounding area to stop a possible forest fire until help arrived from the responding fire department. The fire department responded in approximately 45 minutes and extinguished the fire. The cab area, engine compartment and front tires were completely burned. There was some salvage value in the rear bunks, loader, and rear axles/tires.

It is speculated that the fire started near the engine top and spread from that area. It is uncertain, but in that area the initial cause may have been from fuel, oil, and/or possibly debris in the manifold turbo area (fuel igniting from the hot turbo). The turbo/exhaust is partially covered with a heat resistance wrap to control excess heat. Opening the hood cover gave the fire fresh air creating a fastgrowing fire situation. The following suggestions can help prevent problems of this caliber when working with mobile equipment.

- 1. Enforce frequent operator selfinspections for housekeeping and maintenance, especially in dirty timber. Completing these preventive maintenance repairs quickly (electrical, hydraulic/fuel hoses, part replacement, etc.) before the fact will help keep your operation profitable.
- 2. Install fire port holes in equipment side panels for fire extinguisher use during fire emergencies. This needs to be part of employee training and a refresher training program for emergency response.
- 3. Maintain all side panels on mobile equipment with quick

- opening fasteners. Fast access is very important in an emergency.
- 4. Review the hood tops to prevent debris from entering the engine compartment. This should include blocking of all openings or problem areas (rear hood, canopy openings, etc.).

- 5. Train employees on proper use of fire extinguishers in an emergency situation. Utilizing the extinguisher hose to direct the flow to the base of the fire so the extinguisher is not wasted in a panic situation.

- 6. Always shut down the electrical disconnect (master switch) on mobile equipment in an emergency situation. Refresher training for all employees needs to be reviewed regularly.

- 7. Complete refresher of employee training for proper operation, service, emergency response, etc., for new and existing employees. Weekly tool box safety meetings work well in reviewing all equipment. Cross training all employees is very beneficial.

- 8. Install an on-board fixed selfsuppression system on all mobile equipment. Additional protection is always very beneficial in a fire emergency situation. Always follow the owner's maintenance manual for service and inspection of these systems. This is a very important factor in the performance of this protection.
