Lessons from Losses

Proper Hot Work Procedures Could Have Prevented Fire

by Dave Amundson
Lumbermen's Underwriting Alliance

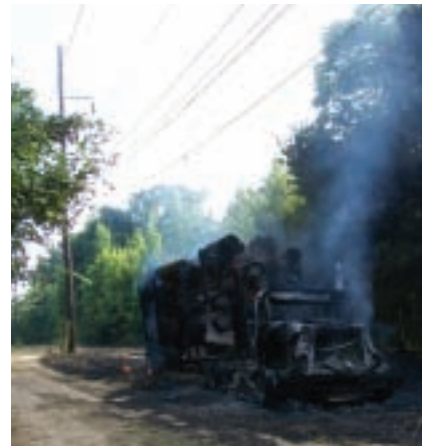
7200 Volts vs Log Truck – Volts Win

It happened in July in Jackson, Tenn. The driver of what used to be a truck and trailer was attempting to throw the logging cable over the logs to secure them. As you can see, he hooked the electric line instead!

The tires began to fry within seconds, but the driver was a very lucky man. He survived, but could easily have been fried himself!

All who haul timber should keep this photo in mind and remember to maintain the proper distance away from the power lines.
