Lessons from Losses

Vandalism Strikes a Cut-To-Length Harvester

by Dave Amundson
Lumbermen's Underwriting Alliance

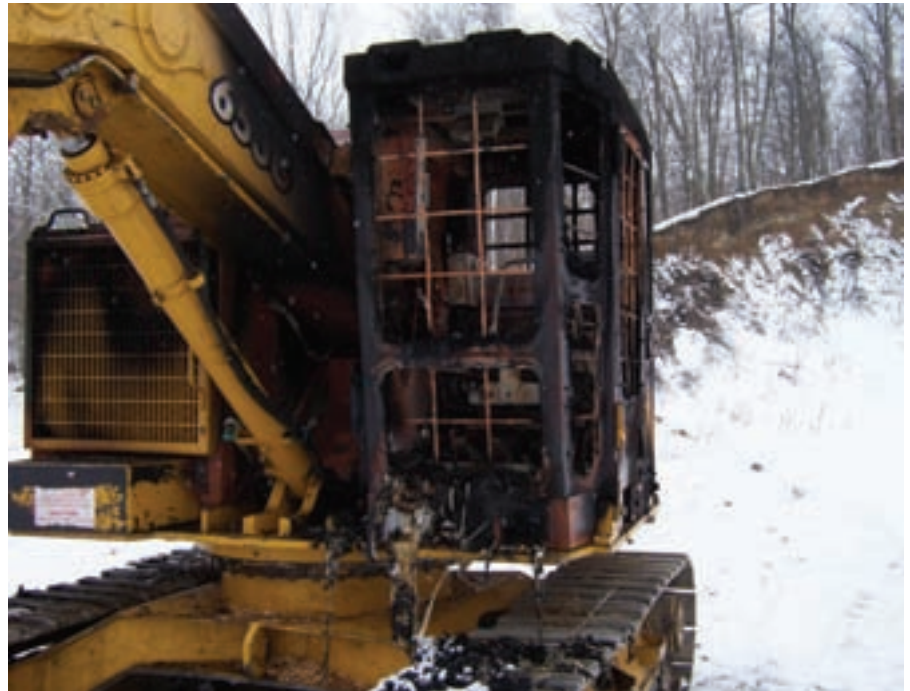
Incident: At first light this equipment was found completely burned in the engine, hydraulic, boom and cab areas. The snow

Cut-to-length harvester destroyed by vandalism

immediately called due to physical evidence that the machine had been tampered with and debris was thrown out in the immediate area. Evidence was collected by the local sheriff's department and the investigation is currently active. This rear access door to the engine compartment was left open and evidence of starting a fire was present. The engine, hydraulic, boom, and cab areas were completely destroyed, however, there was salvage value in the track system and processing head.

1. Restrict vehicle access to job sites during off-hours to protect equipment. Use a gate, boulders, dirt berm, or a drag of trees to stop traffic.
2. Use private access to timber sales when possible.

4. Remove keys, lock doors, and turn off master switches when leaving the job overnight. Additional master switches for electrical and fuel systems can be added for backup and security.

5. Lock fuel, oil, and engine compartments to prevent tampering. Add locks if they have not been installed from the factory.
6. Park equipment away from ignition sources. Stay back from slash piles that could be ignited. Space equipment at least 50 feet apart to reduce chance of fire spreading from one machine to another.

10. Install an on-board fixed self-suppression system on all mobile equipment. Additional protection is always very beneficial in a fire emergency situation. Always follow the owner's maintenance manual for service and inspection of these systems. This is a very important factor in the performance of this protection.
